The Open Construction and Building Technology Journal

RESEARCH ARTICLE

Ductile Compressive Failure of Concrete Reinforced with High Strength Carbon Hybrid Composite

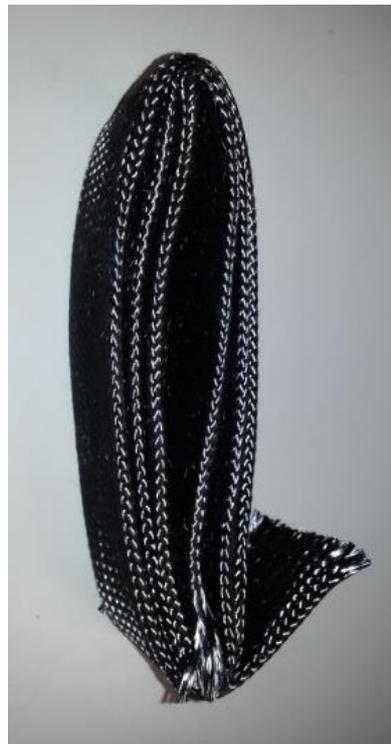
Fig. (1). Folded HC reinforcement.

HC reinforcement, made from various pattern fiber bundles, is preformed to various geometric shapes including flat plate, curved plate, and circular tubes. Specific shapes and dimensions are designed for shear, flexure, compression, and ductility capacity for concrete structures in place of steel reinforcement. In this study, HC reinforcement is made of a carbon fiber fabric in the form of a very flexible tube to be used as longitudinal reinforcement and confinement for cylindrical concrete columns. Such tubular structures can be produced by weaving, braiding, or knitting. The angles between the interlocking fiber strands should be properly designed in order to tailor the load-deformation behavior of HC reinforcement, which must depend on specific structural requirements. Interlocking strands of various angles can produce a wide range of increases in fabric ductility since load transfer after a local strand rupture is possible to occur via a lock-up mechanism involving strand waviness and overall failure can be delayed until all adjacent strands rupture. The flexibility of HC reinforcement has many advantages. The material can be produced in almost any length, and it is easy to fold, unfold, and pack, which makes it easy to transport (Fig. 1). It is also easy to handle, and can be conveniently cut to any desired length. Different reinforcement ratios can be readily achieved by repeatedly folding HC reinforcement as needed. Such measurements of reinforcement ratios are represented by the number of layers of HC reinforcement in this paper.

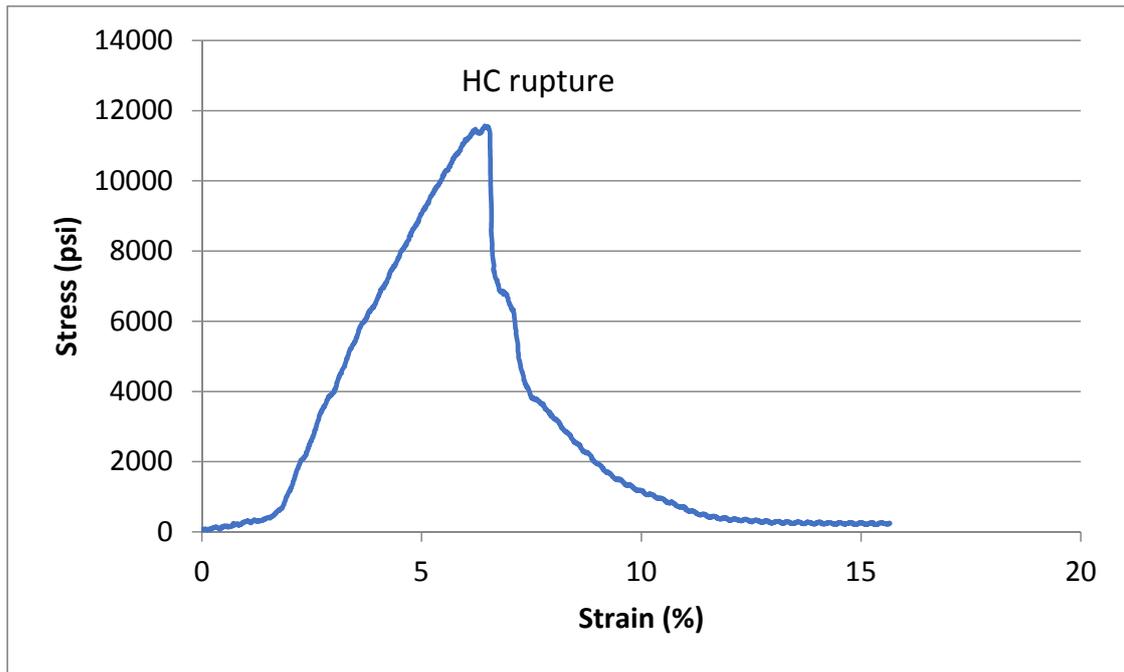
Fig. (2). Stress - Strain diagram (L-NC-1).

All of the light HC specimens were made of 2-layers without cover. Fig. (2) presents a typical stress-strain diagram. All of the small column specimens displayed a sudden failure with HC reinforcement rupture characterized by a sudden drop of capacity around the peak stress (Fig. 3). The stress capacity then fell sharply towards zero.

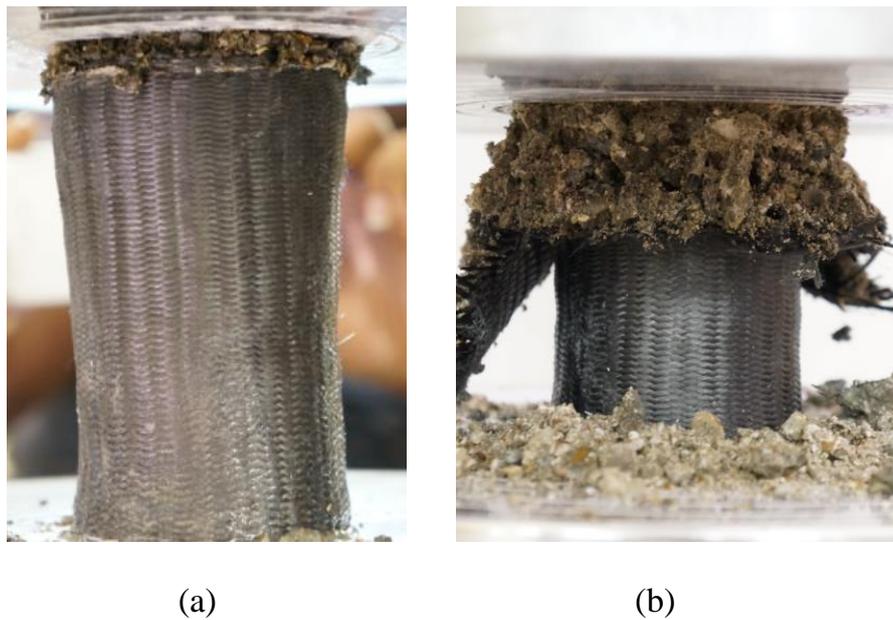
Fig. (4). (a) Start of HC shortening (H-NC-4), (b) progressive rupture at second peak (H-NC-4).

All the heavy HC columns displayed similar stress-strain behavior and failure modes. They showed a first peak as the HC started to shorten (or retract) and gave way to a small open concrete portion at the top (Fig. 4a). As this concrete continued to break off and fall on the sides of the column, the column shortened and the HC reinforcement started to rupture along the edges at the top (Fig. 4b). However, this rupture was localized on the top layers only in contrast with the sudden global rupture of the HC for the light HC columns. As the HC reinforcement continued to retract and rupture, the core concrete still remained confined. This slow and localized rupture allowed the column to continue to carry significant loads and a second peak was observed (Fig. 5). The strength started to decrease only after a larger rupture of the HC occurred.

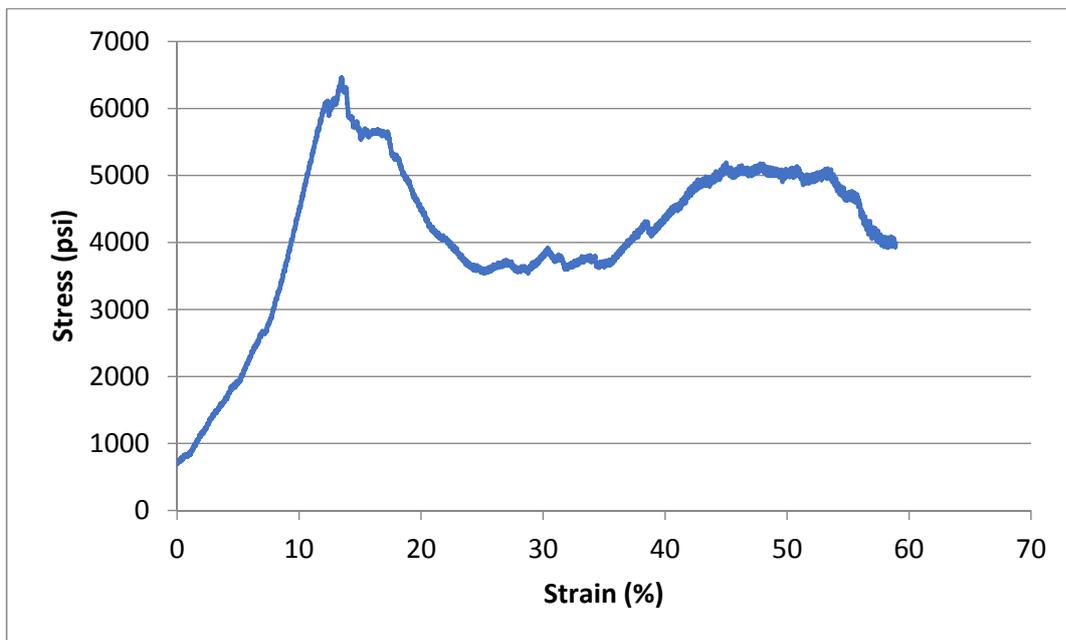
Fig. (5). Typical stress-strain diagram.

The ideal compressive response of concrete columns reinforced with HC reinforcement should show two-peak behavior, which is caused by the progressive rupture of the HC as the column fails, similar to that of Figs. (5 and 11). Obviously, a smaller load drop after the first peak is preferred. The issue of how to control the initial load drop is critical and can be improved by the optimal design of the hybrid fiber materials and the twist angles of interlocking fiber strands, on which research is on-going and will be reported in a future publication.

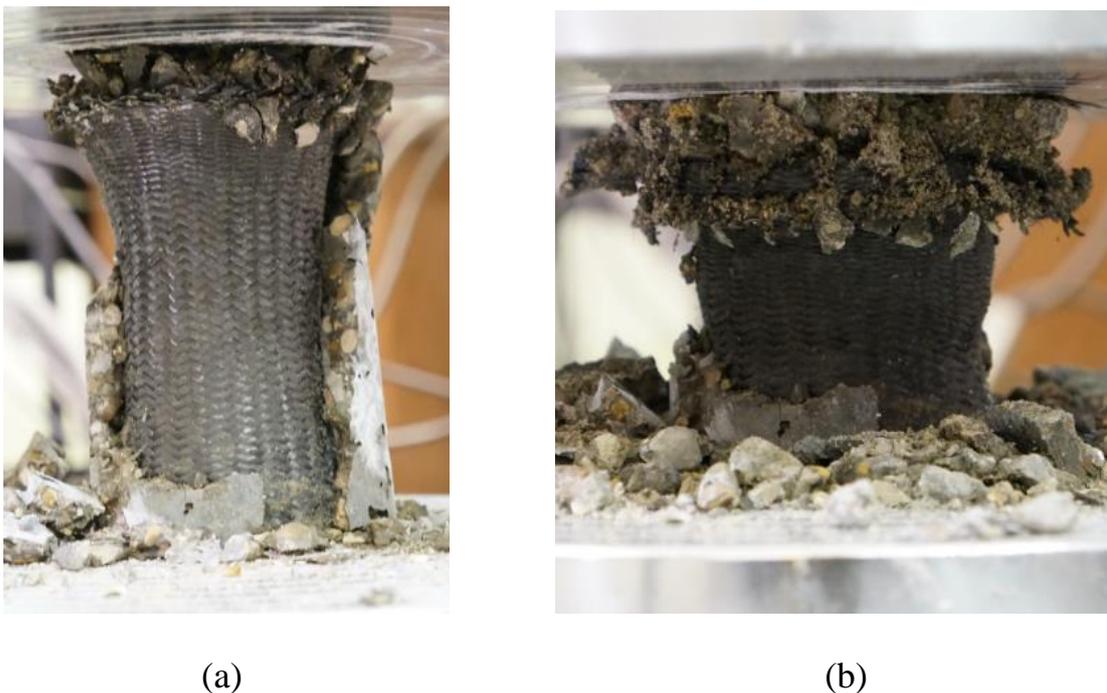
Fig. (6). (a) Concrete cover spalled off, (b) at failure (H-CC-1).

The presence of small pockets of air inside the cover induced the cover to start spalling off at a relatively low applied load. However, since the core of the column was still effectively confined, the column started behaving similar to previous no-cover columns after much of the concrete cover had spalled off. The HC first started shortening around the peak stress (Fig. 6a), then the HC started rupturing at the top layers and the stress consequently started decreasing (Fig. 6b).

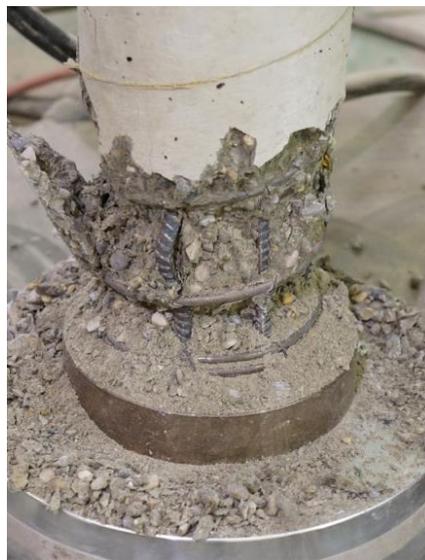
Fig. (7). B-30.63 local buckling failure.

The second base column B-30.63 displayed a similar load capacity but experienced a slightly different failure mode. Similar to B-30.25, this sample started experiencing stress concentration around the wooden spacers at a stress capacity of 2,600 psi (17.9 MPa). The concrete spalled off at a faster rate however, holding the capacity of the column around this peak stress capacity until a significant portion of the re-bar is exposed. The stress increased to a peak around 2,800 psi (19.3 MPa) where individual longitudinal re-bars started to buckle (local buckling), prompting the column to fail (Fig. 7).

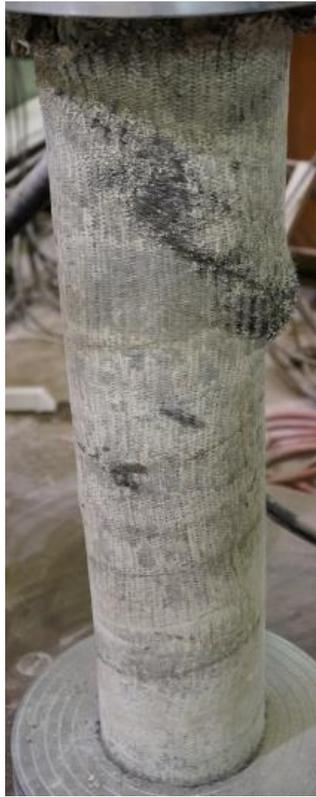
Fig. (8). 1L-28 final failure along the shear line.

All columns (1L-18.25, 1L-19, 1L-28) displayed a very sharp increase in load capacity with little deformation reaching a peak around 2,200 psi (15.2 MPa). At this load, the failure started to appear on the HC reinforcement following a shear line (Fig. 8). This shear line had a 45 degree angle with the axis of the column. These columns did show a small degree of ductility increase, but the first stress peak in this case coincided with HC rupture and the columns failed concurrently.

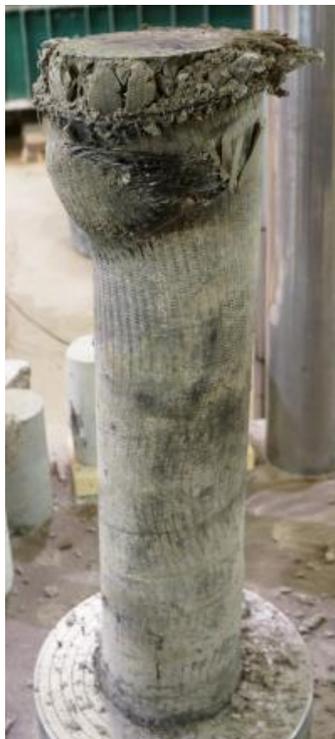
Fig. (9). 2L-30 failure.

For 2-Layer HC columns, the tendency towards the much ductile behavior of the small heavy HC columns is much clear compared to the 1-Layer columns. All 2-Layer columns clearly displayed an intermediate failure mode between the brittle mode of the small light HC columns and the ductile mode of the small heavy HC columns. The initial peak was observed when the HC started shortening at the top. The first load peak was followed by a drop in capacity due to the crushing failure of the top layer concrete. The load capacity increased again after pseudo-strain hardening and a second peak was reached at which point the HC ruptured and the column failed (Fig. 9).

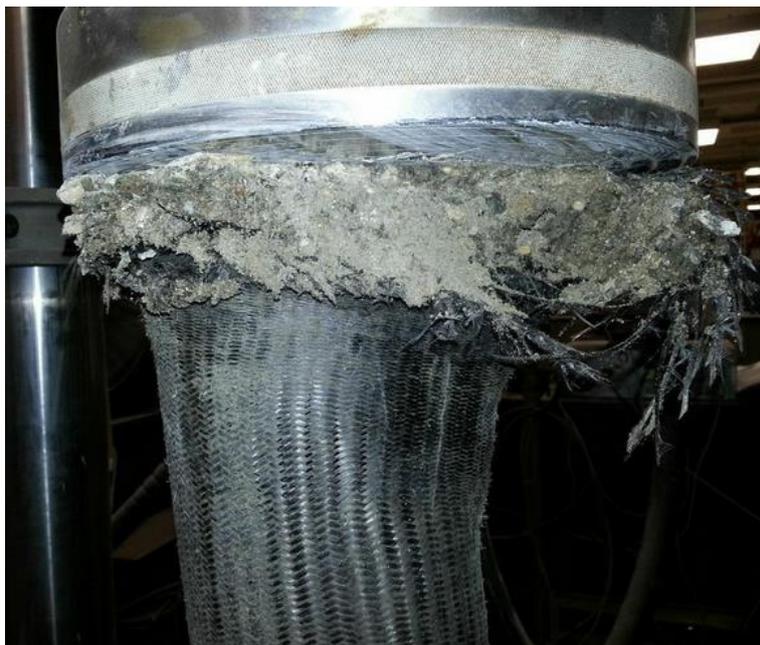
Fig. (10). 3L-31.25 at failure.

The behaviors for both 3-Layer columns were very similar. There was a steep rise in stress capacity with a peak strength around 3,000 psi (20.7 MPa) with a small corresponding strain of 1%. At the peak load, the HC reinforcement started to retract from the top (or bottom) of the columns, exposing the very top portion of concrete that started to crush (Fig. 10). The load capacity then dropped by around 30-50% at which point the capacity was maintained for a long period of time experiencing large strains (Fig. 11). It is also important to note that the HC reinforcement never globally ruptured indicating that the number of layers was enough to carry the applied loads. The test was terminated due to an excessively large displacement.

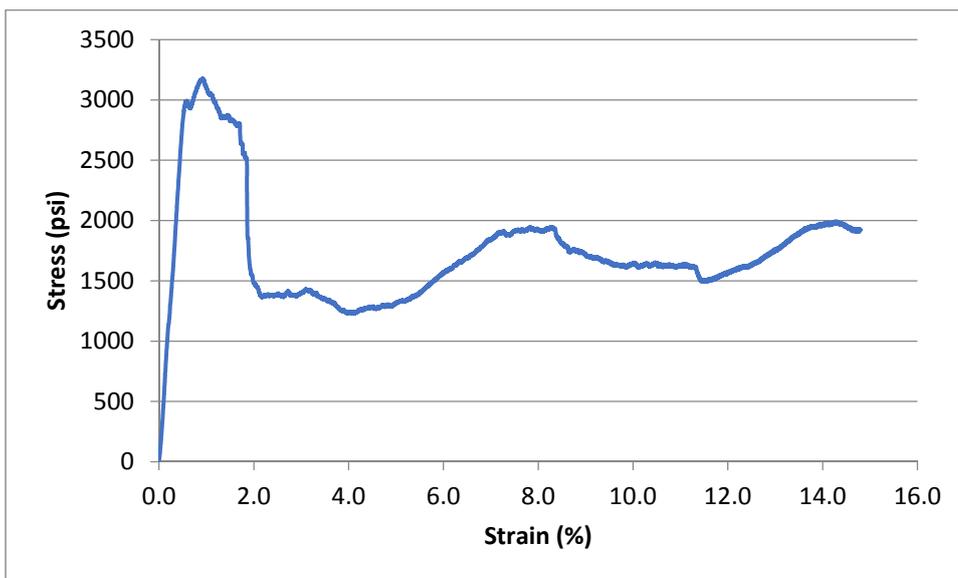
Fig. (11). 3L-31.25 Stress-strain diagram.
